State Climatology
Office

Open File Report: Tornadoes of Early April 2022

January 12, 2023

This report serves as a preliminary dissemination of information on the impacts of the April 5-6, 2022, tornado outbreak on the state of South Carolina.

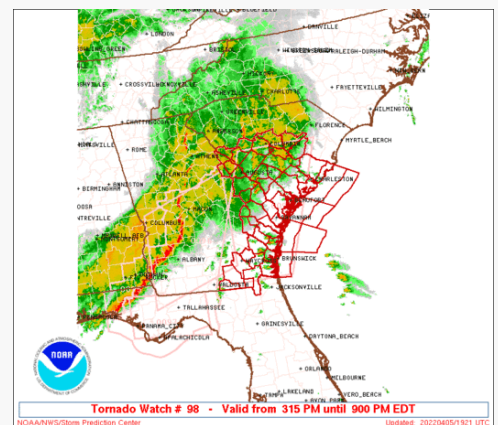
Tornado Watch 98, issued by SPC at 3:15 p.m. EDT on April 5

The first of two weather watches issued on April 5 was a tornado watch issued by SPC at 3:15 p.m. EDT. By this point, the warm front was over the Midlands and CSRA, with a favorable environment for thunderstorms to the south of it to produce tornadoes. The watch covered the CSRA, Midlands and Lowcountry regions of South Carolina and adjacent areas of Georgia. The second watch was a tornado watch issued at 5:45 p.m., which covered most of the Pee Dee region.

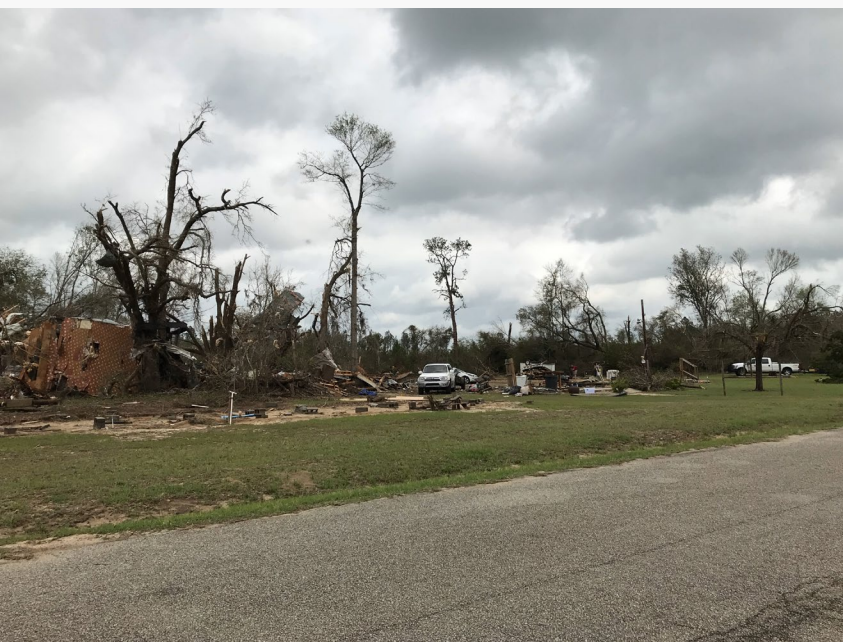
One of a few mobile homes that were demolished by this tornado southwest of Allendale. Also, the mobile home's undercarriage was lifted and moved about 30 feet. Significant tree damage is also evident.

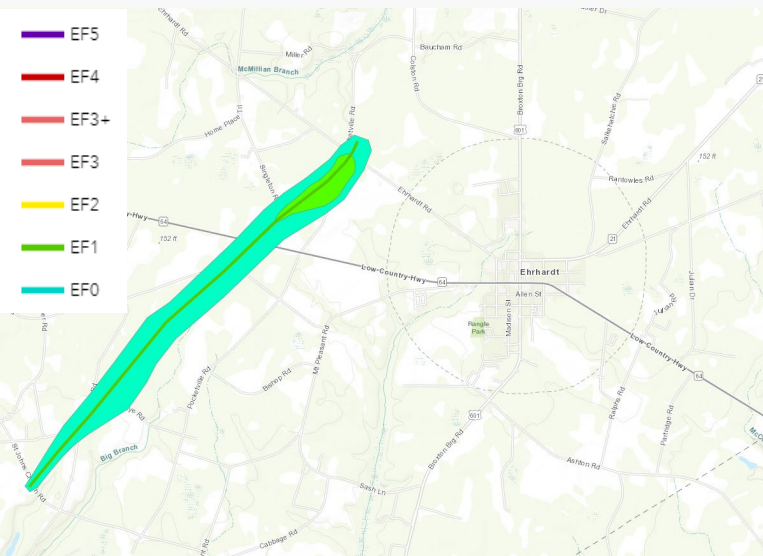
2: The 2022 Ehrhart Area EF-2 Tornado

This second tornado of the outbreak began near St. John's Church Road and tracked northeast across Low Country Highway and Singleton Road. While crossing a property on Pocketville Road, a shed was destroyed, several vehicles and a tractor were spun or shifted, and shingles and siding damage occurred to a home. It dissipated near the intersection of Pocketville and Ehrhardt Road after destroying a shed and damaging a home in the area. Considerable tree damage was reported along the damage path, including 12 large pecan trees uprooted near the end of the track.

A map showing the track, damage areas and NWS survey team damage points from the 2022 Ehrhart Area EF-2 Tornado, which began at about 4:18 p.m. on April 5, 2022, and was on the ground for about nine minutes.

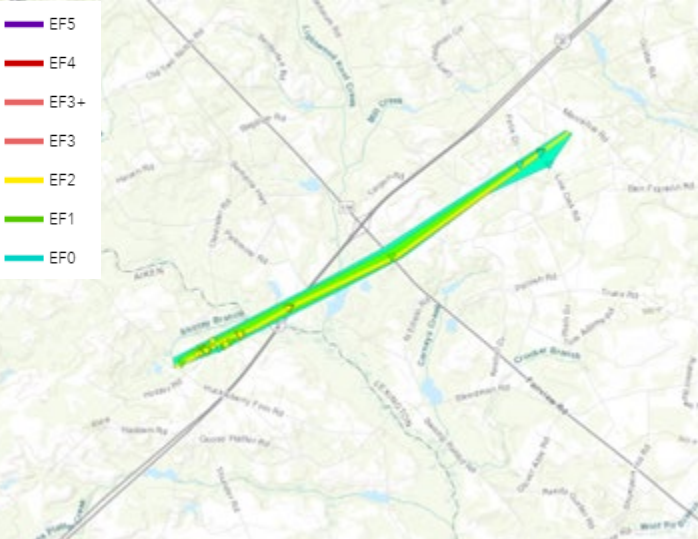
A map showing the track, damage areas, and NWS survey points from the 2022 Aiken-Lexington Line EF-2 Tornado, which began at about 6:35 p.m. on April 5, 2022, near the Aiken-Lexington county line just north of I-20 and was on the ground for about 12 minutes.

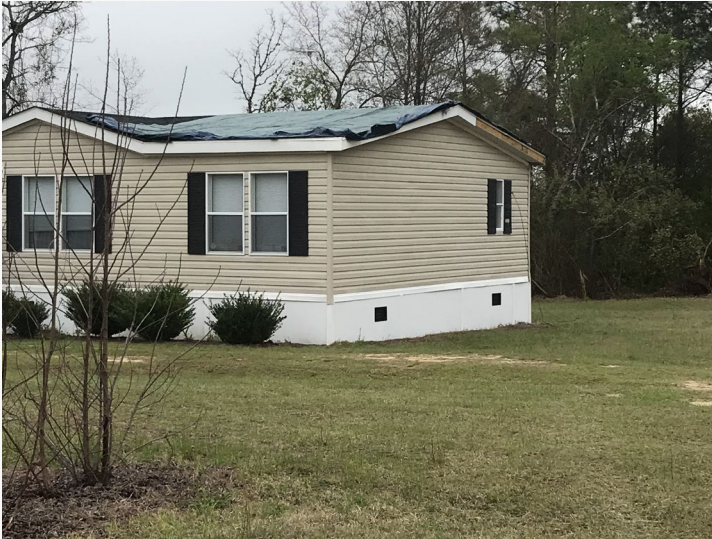
While primarily tree damage was caused by this tornado, there was some minor damage to structures, such as the shingle damage to this home.

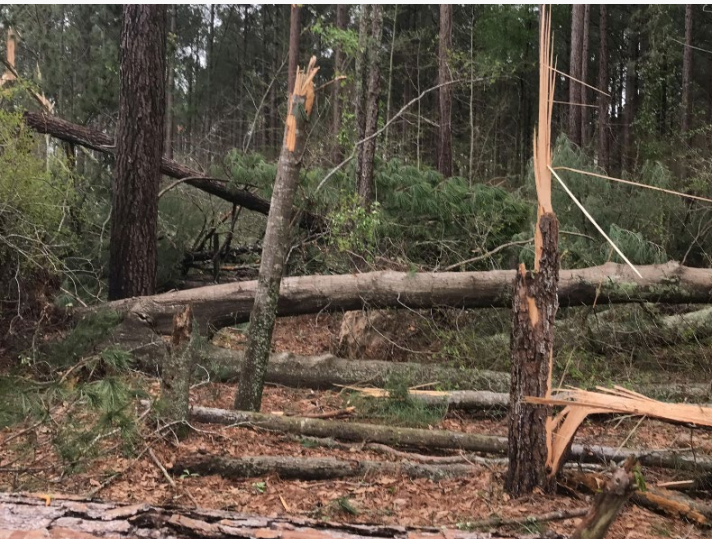
A photo of tree damage along I-20 close to the Aiken-Lexington County Line.

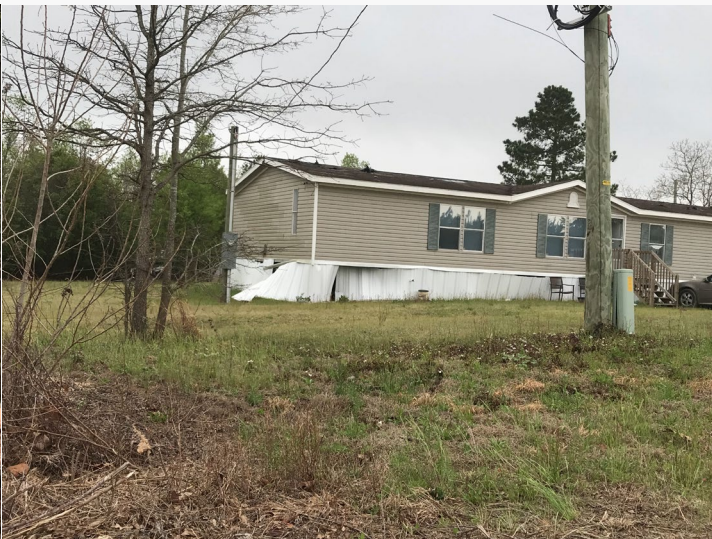
Damage to a mobile home's underpinning along Annie Hallman Road in Lexington County.

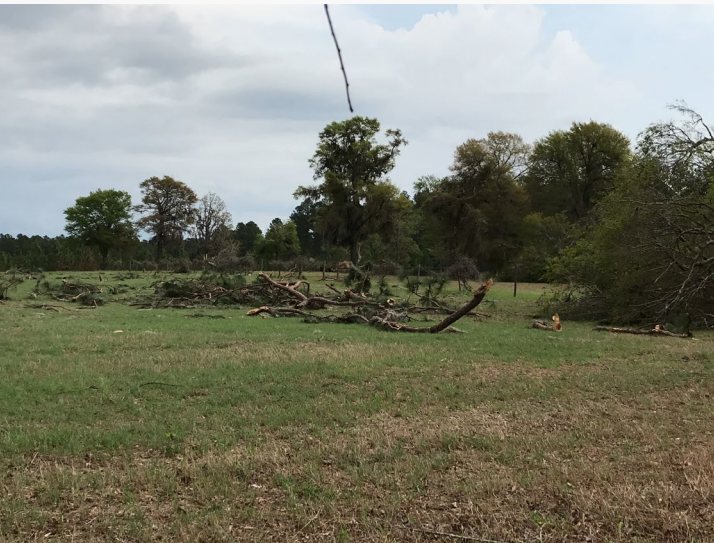
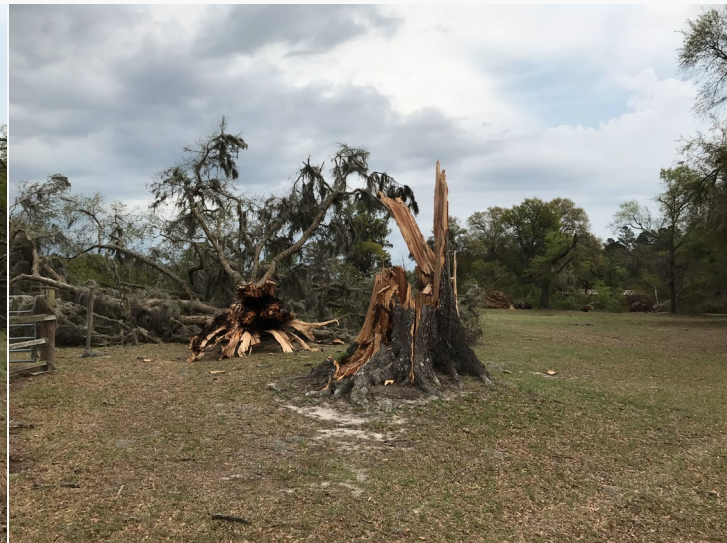
Photos of tree damage caused by this tornado on the west side of Wells Branch Road.

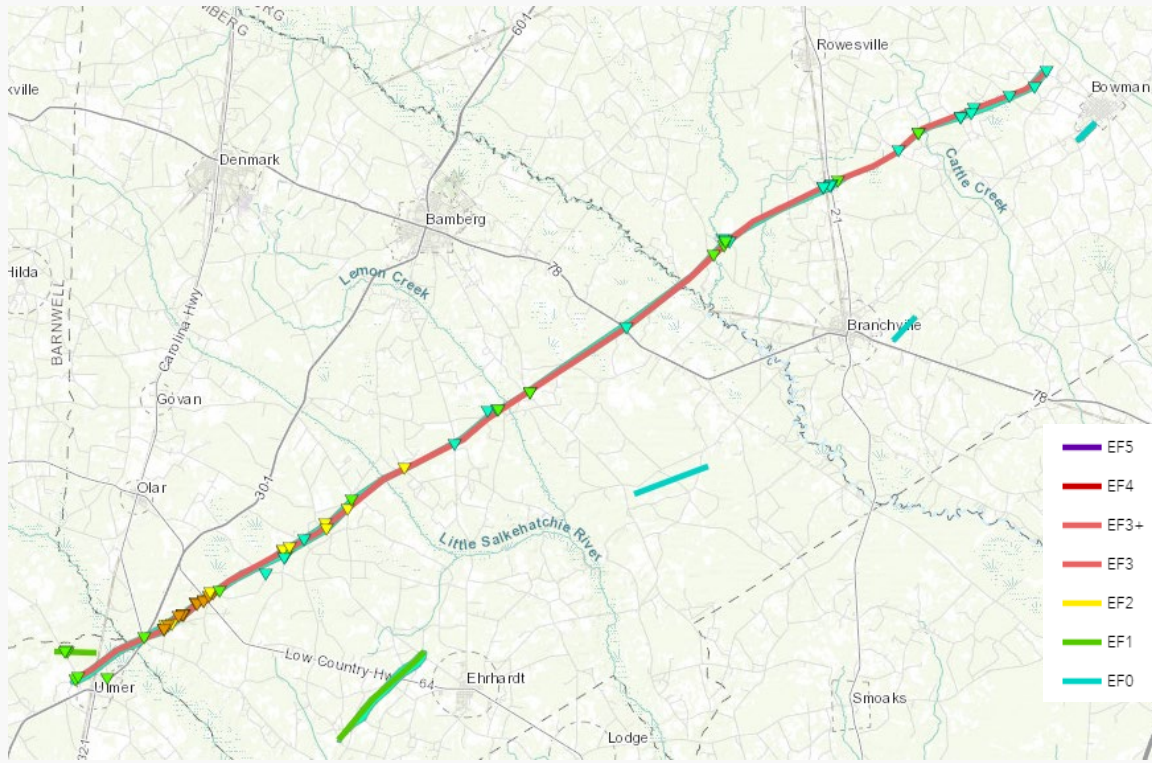
This long-tracked tornado was the eighth of the event and began near Ulmer just west of Well Branch Road and snapped trees and telephone poles in this area. It tracked northeastward to the intersection of U. S. Highways 321 (Carolina Highway) and 301 (Main Highway), downing or snapping many trees, with at least one falling onto a home. Just northeast of there, the tornado became very intense in a forested area along Popeye Road, destroying 80-100 percent of mature trees in this area, with younger pines stripped of needles or debarked and delimbed. From there, the tornado tracked across S. C. Highway 64 (Low Country Highway) and Wild Flower Road, causing additional heavy damage to the forest. It then struck a residential area along Carver Road, where a mobile home was destroyed, and an older site-built home was severely damaged. Other homes saw damage to their roofs or siding. The tornado then crossed Little Salkehatchie River and U. S. Highway 601 (Broxton Bridge Road), where more tree damage was reported. The tornado was weaker as it crossed U. S. Highway 78 (Heritage Highway) and the Edisto River into Orangeburg County. However, it regained strength in Orangeburg County, damaging several homes along U. S. Highway 21 (Freedom Road) and causing considerable additional tree damage. The tornado weakened on approach to the Bowman area and dissipated just north of Bowman, though damage was found to many trees and a few structures just west of that town. In all, many thousands of trees were snapped off or uprooted with dozens of homes damaged. This is the strongest tornado of 2022 in South Carolina to date as of this report's release. It's 34.81-mile path is also the longest of 2022. The tornado's average forward speed, about 42 miles per hour, illustrates why one in the path of a tornado should never try to outrun a tornado in a vehicle, as weather, traffic and road conditions would prevent a driver from maintaining a significantly higher average speed than this.

A map showing the track and damage areas from the 2022 Tri-County EF-3 Tornado (red line), which began at about 6:03 p.m. on April 5, 2022, and was on the ground for about 50 minutes. The tracks of five other tornadoes that occurred earlier or around the same time that day can also be seen on this map.

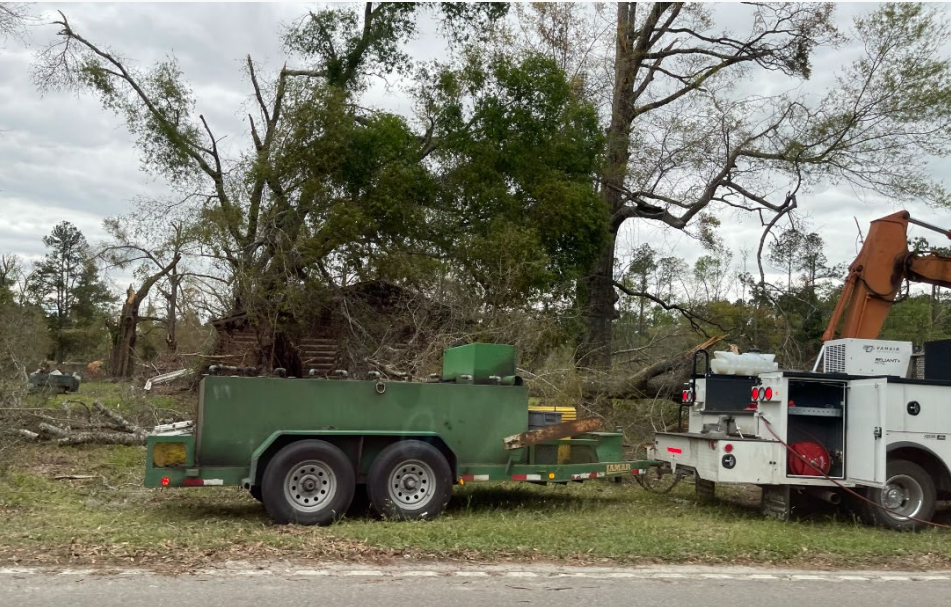
A crew works to remove trees on April 9, 2022, near and around a cabin near Ulmer, near the start of the damage path of the 2022 Tri-County EF-3 Tornado.

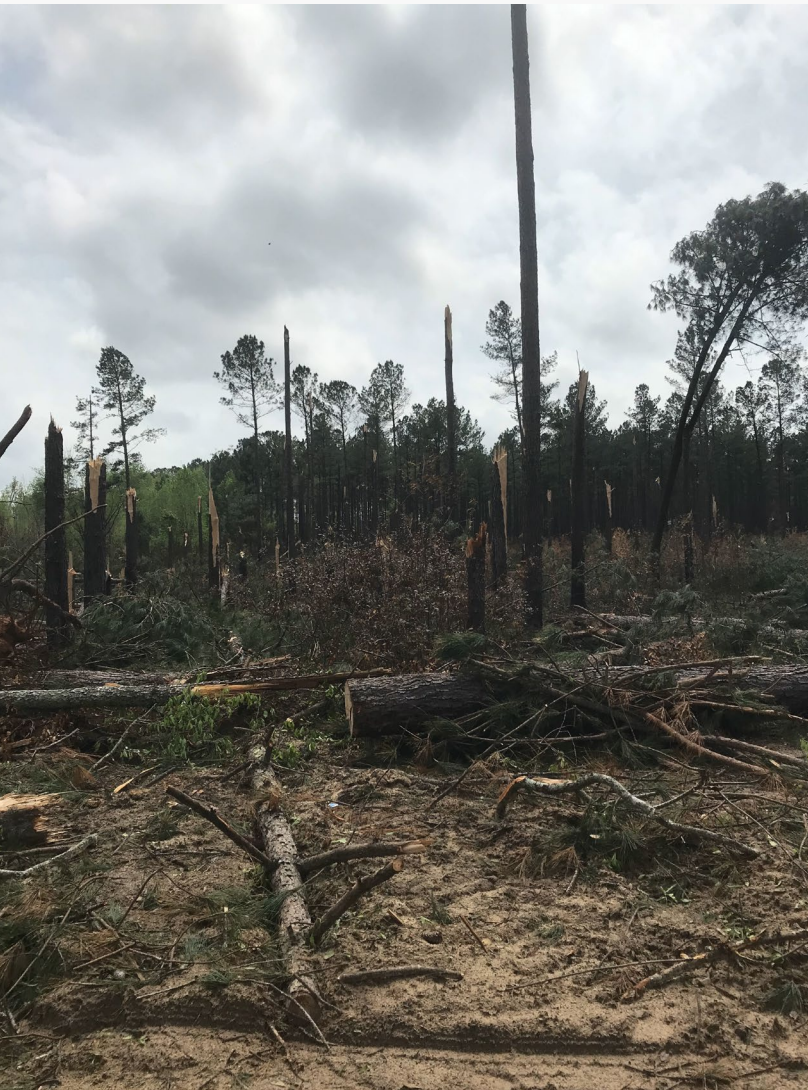
A photo of extreme tree damage caused by the 2022 Tri-County EF-3 tornado. In Barnwell County, where the tornado was most intense, nearly all the trees in the damage path were snapped or uprooted. Similar tree damage was found in an area nearly two miles long and about 150 yards wide in Bamberg County, stretching roughly from the intersection of Popeye Road and Ebenezer Road to Wildflower Road just northwest of S. C. Highway 64 (Low Country Highway).

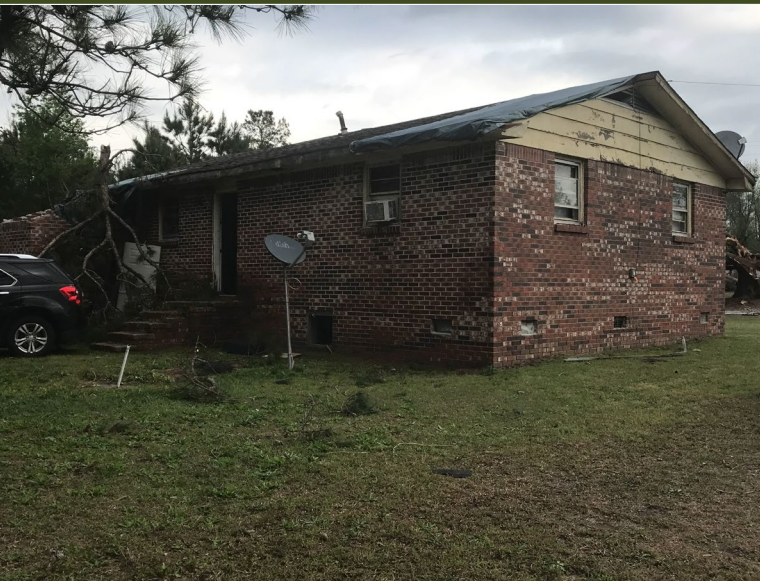
The tornado caused damage to the roof and siding of this home along Greywood Drive in Orangeburg County and dropped a large limb onto it.

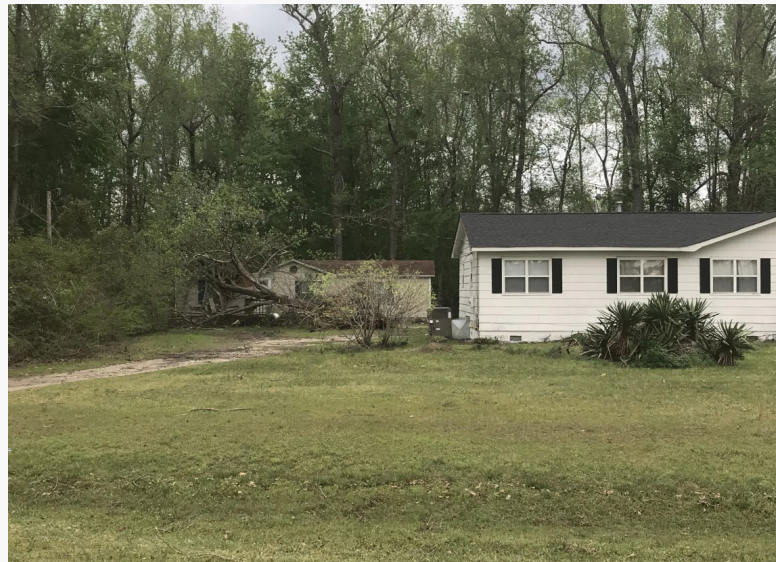
A tree was uprooted by this tornado along U. S. Highway 21 (Freedom Road) in Orangeburg County, which fell onto a mobile home and caused extensive damage.

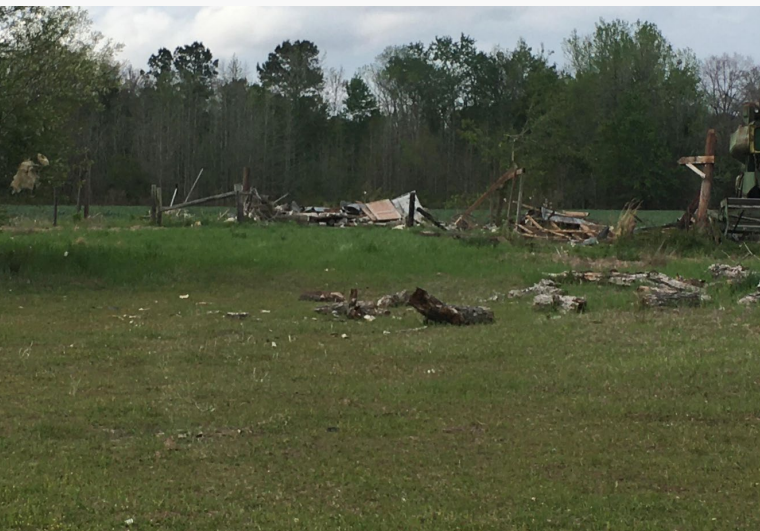
This old stick-built barn along Cramer Road in Orangeburg County was destroyed by this tornado.

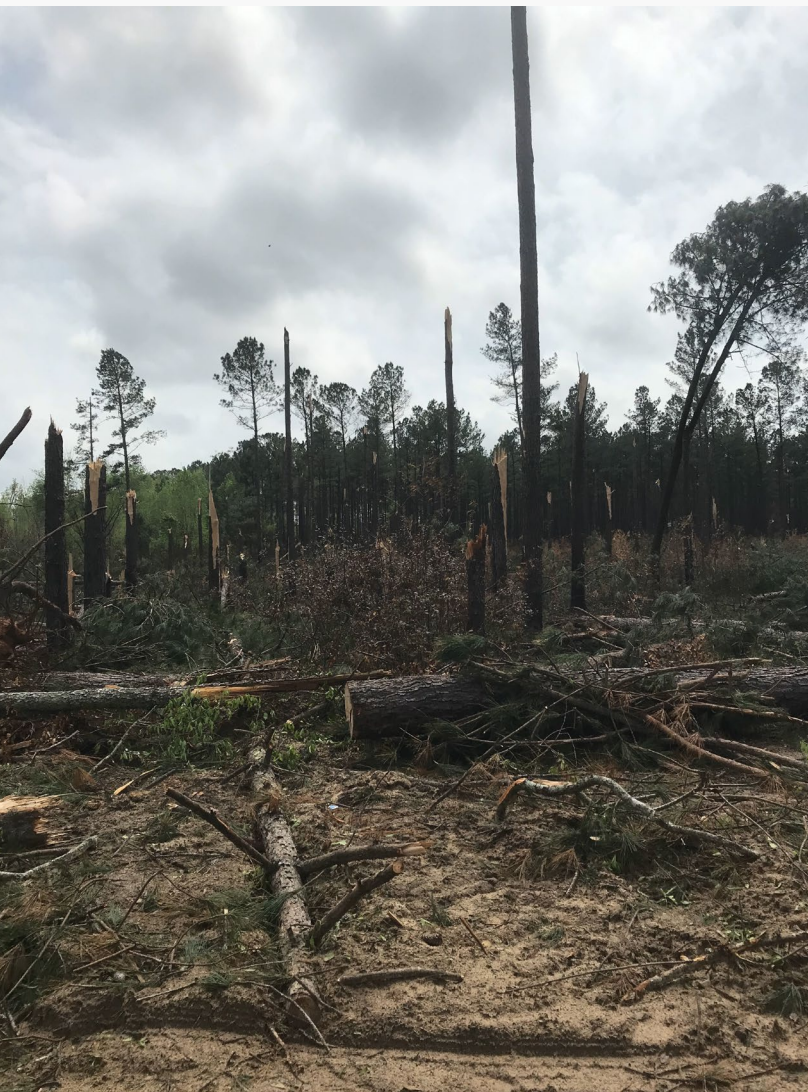
A photo of extreme tree damage caused by the 2022 Tri-County EF-3 tornado. Nearly all the trees in the damage path were snapped or uprooted by this tornado where it was most intense in Barnwell County. Similar tree damage was found in an area nearly two miles long and about 150 yards wide in Barnwell County, stretching roughly from the intersection of Popeye Road and Ebenezer Road to Wildflower Road just northwest of S. C. Highway 64 (Low Country Highway).

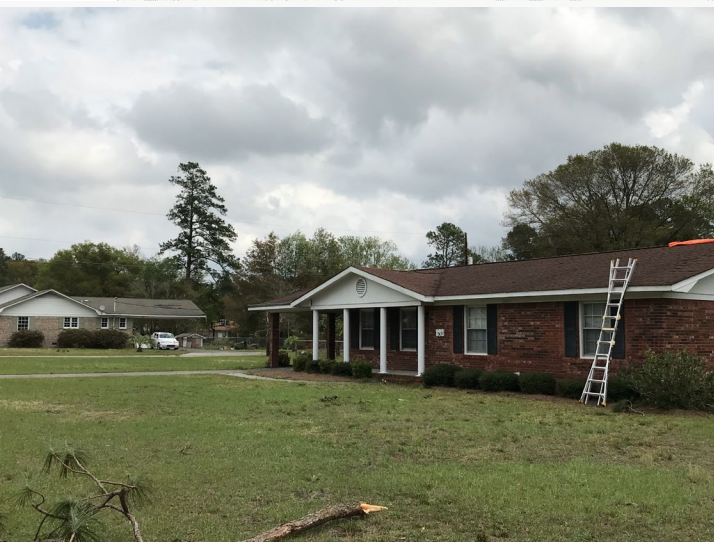
A photo of minor damage to a couple of homes caused by this tornado along Howard Street in Varnville.

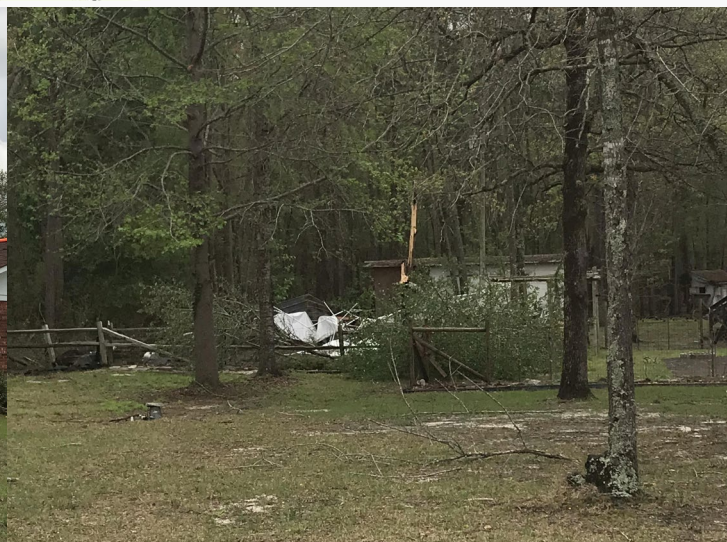
A photo of tree damage and a flipped outbuilding on a farm along Papas Road east of Varnville.

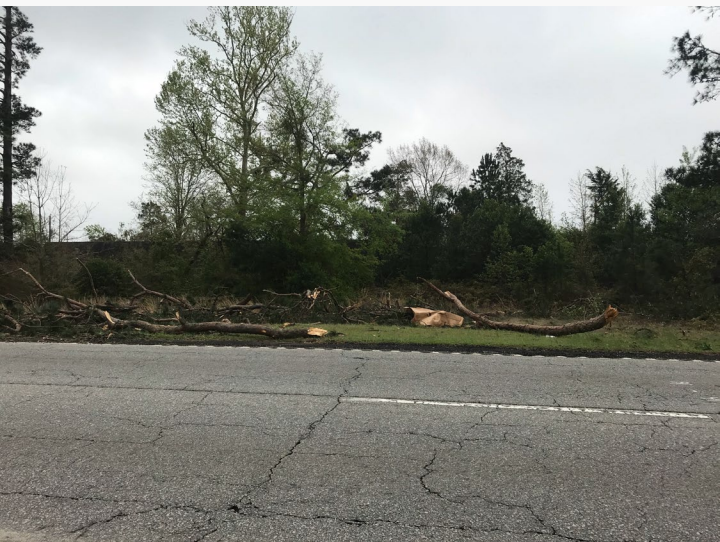
A photo of tree damage along Highway 378 (North Main Street) in Gaston, near the start of the damage path.

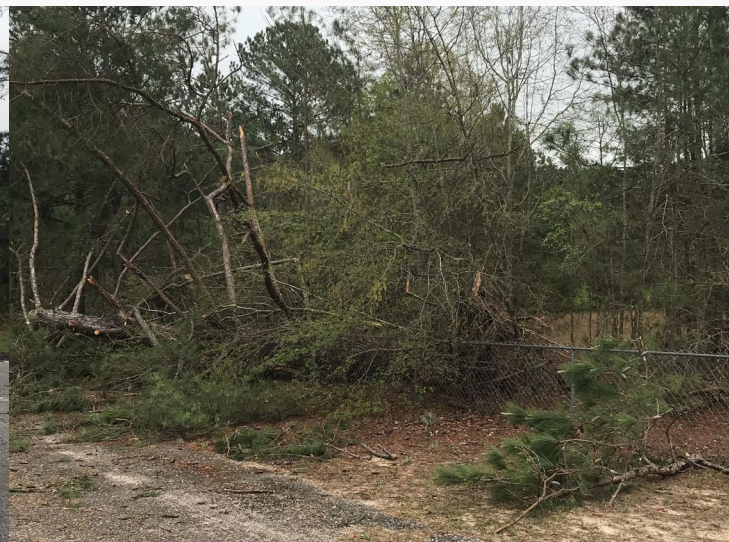
A photo of tree damage near Sandy Run on Plantation Estates Road, near the end of the damage path.

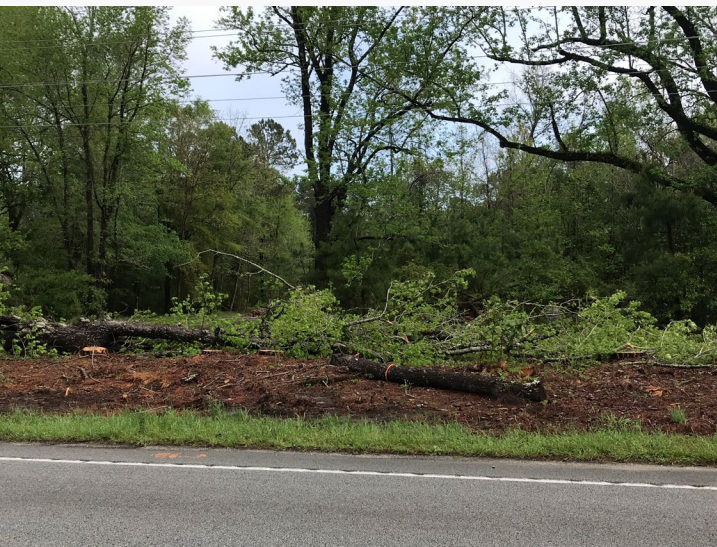
A photo of a downed tree along U. S. Highway 78 southeast of St. George near the start of the tornado damage path.

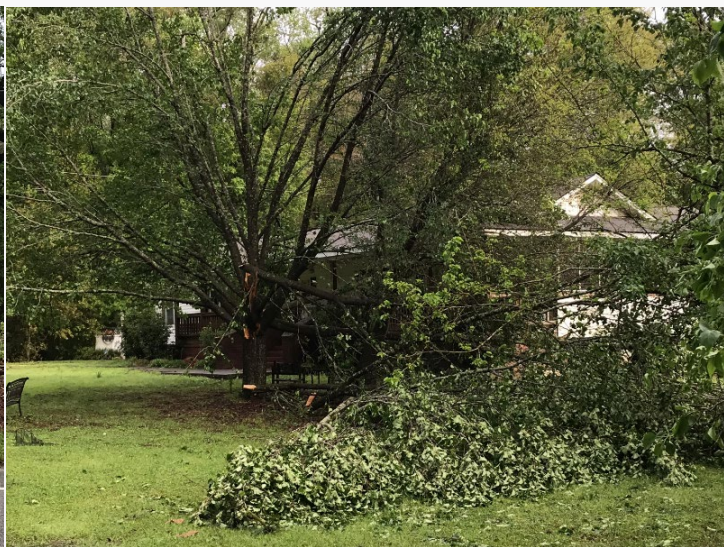
A photo of tree damage at a residence near the end of the damage path along U. S. Highway 178 (East Main Street) in Harleyville.

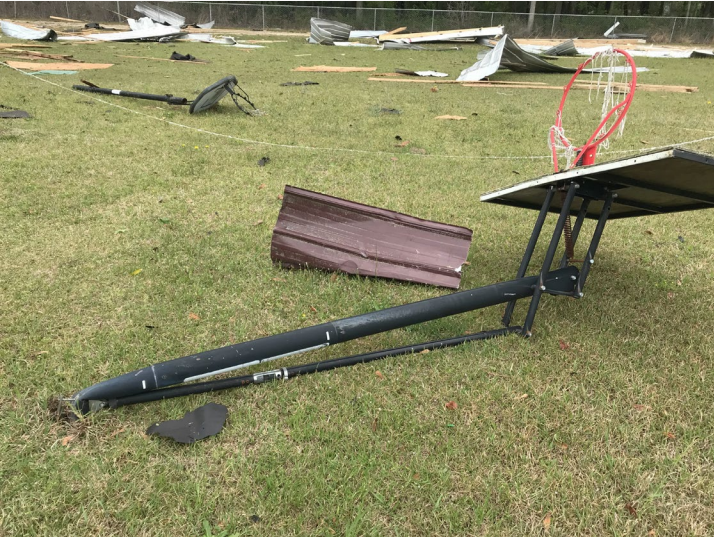
A photo of a basketball goal bent over by the tornado's winds and debris from a nearby building's roof along West Huggins Street in Manning.

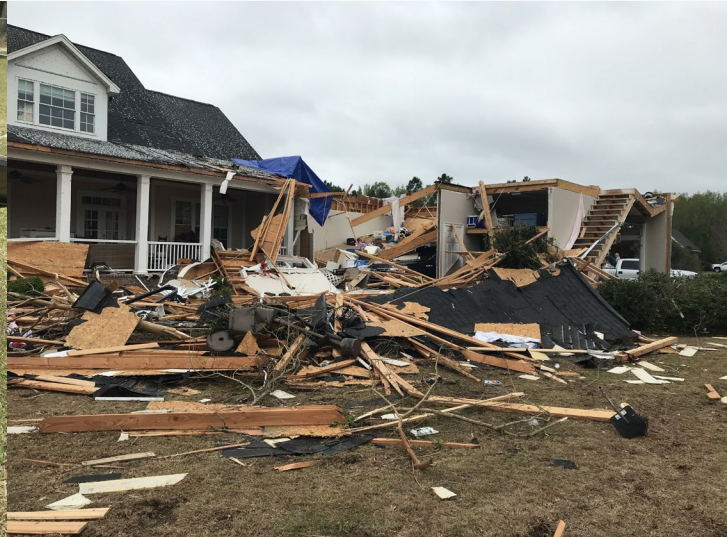
A photo of significant damage to a residence on Gossett Court north of Manning. Hurricane clips on this home's roof likely prevented even worse damage.

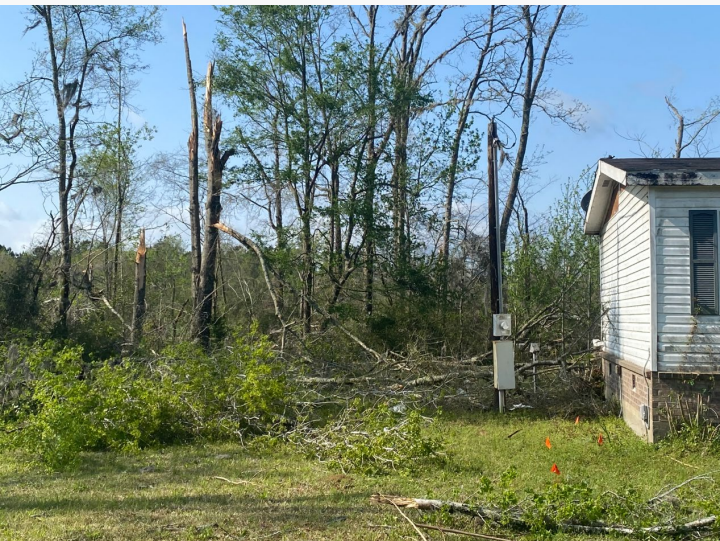
A photo of tree damage and minor roof damage to a home along Bay Road in Marion County.

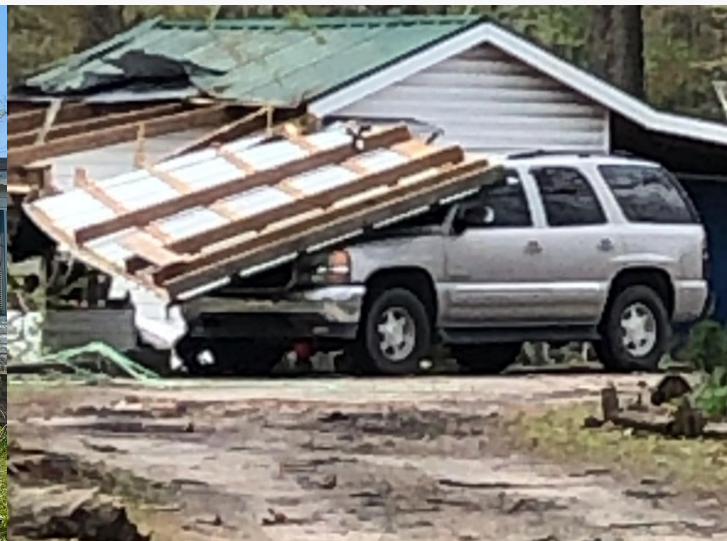
A photo of damage to a home and vehicle along Gunter's Island Road southwest of Aynor in Horry County.

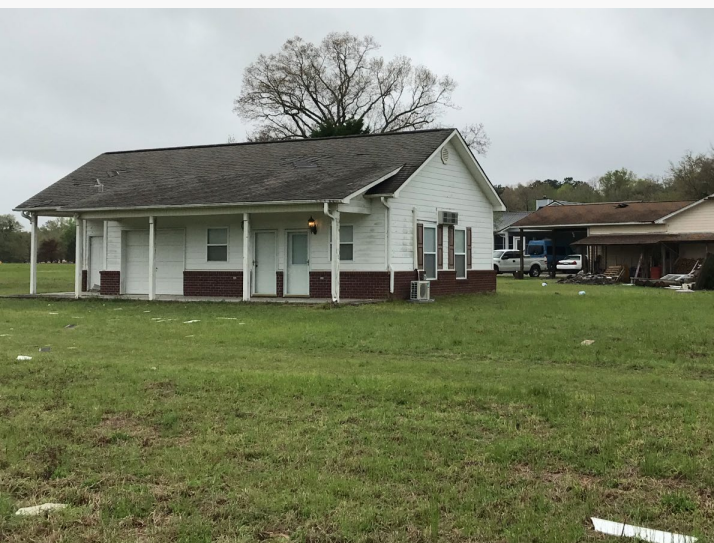
A photo of shingle damage to a home and debris in its yard from this tornado along Sandy Springs Circle west of Walterboro.

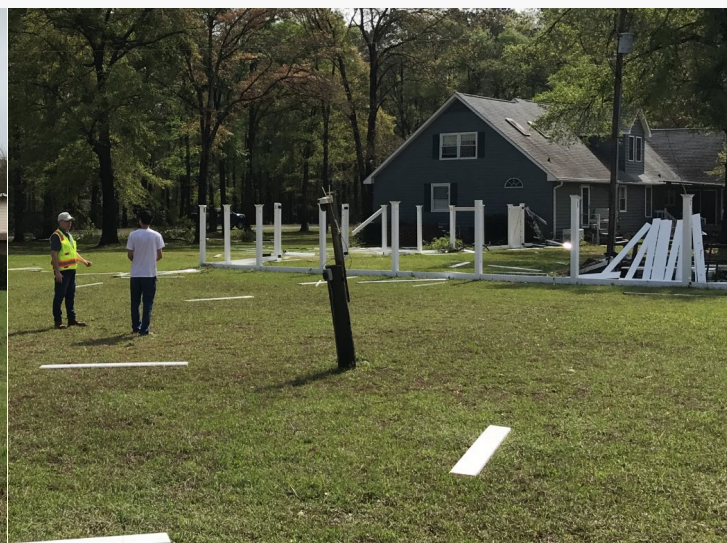
A photo of a fence destroyed by this tornado at a residence along Sandy Springs Circle west of Walterboro. A shed on this property was damaged as well.
