**FINAL REPORT**  
**South Carolina State Wildlife Grant F21AF03715**  
South Carolina Department of Natural Resources  
October 1, 2021 – December 31, 2023

**Project Title:** Eastern Brook Trout Restoration in Pig Pen Branch and Lick Log Creek, Oconee County, South Carolina

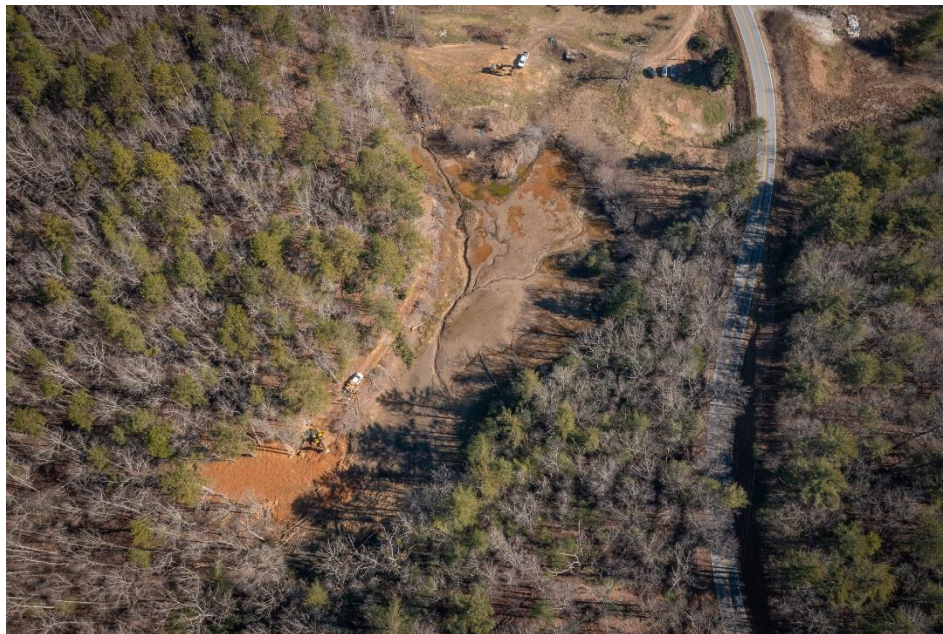
Figure 1. Aerial photo captured by Mac Stone (Naturaland Trust) of Burrell's Pond dam removal.

A temporary siphon was installed by SCDNR and Naturaland Trust to lower the Burrell's Pond water level. After the pond water level was lowered, the existing plastic riser standpipe was notched to keep the streambed in Burrell's Pond dewatered. Winter Rye, Brown Top Millet, Winter Wheat, and granular fertilizer were broadcasted along the pond banks and pond bed to establish temporary ground cover to minimize erosion. The USFWS and USFS removed Burrell's Pond dam in March of 2022, depositing all fill material into an on-site borrow pit (Figure 1). Logs and stumps removed from the preexisting dam were strategically placed along the stream banks to reduce erosion downstream (Figure 2).

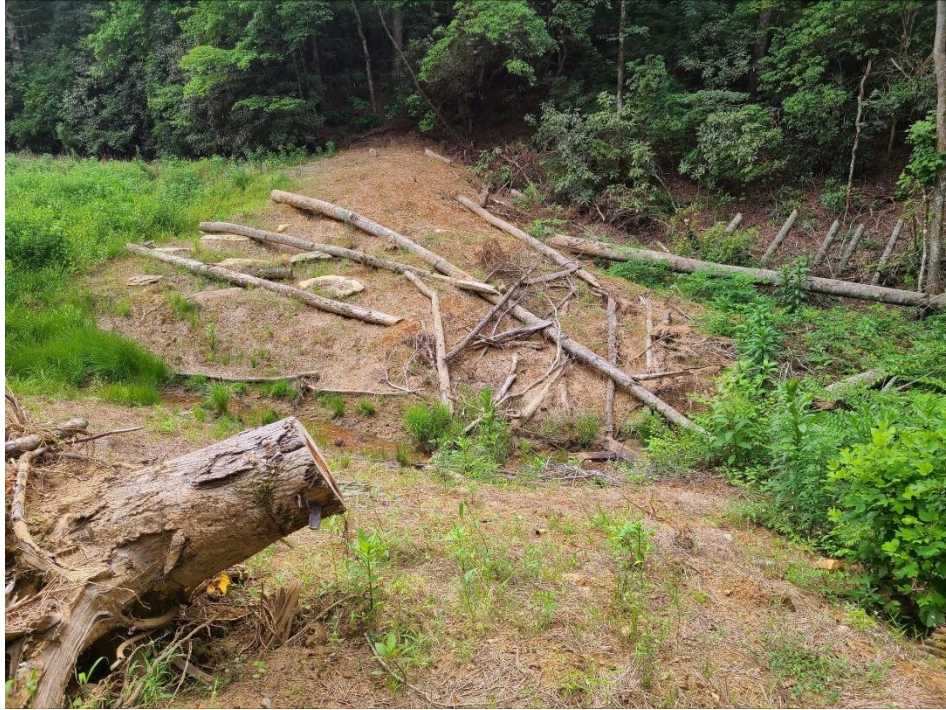
Figure 2. Photo captured by Hailey Goyette (SCDNR) of post Burrell's Pond dam removal and erosion control methods.

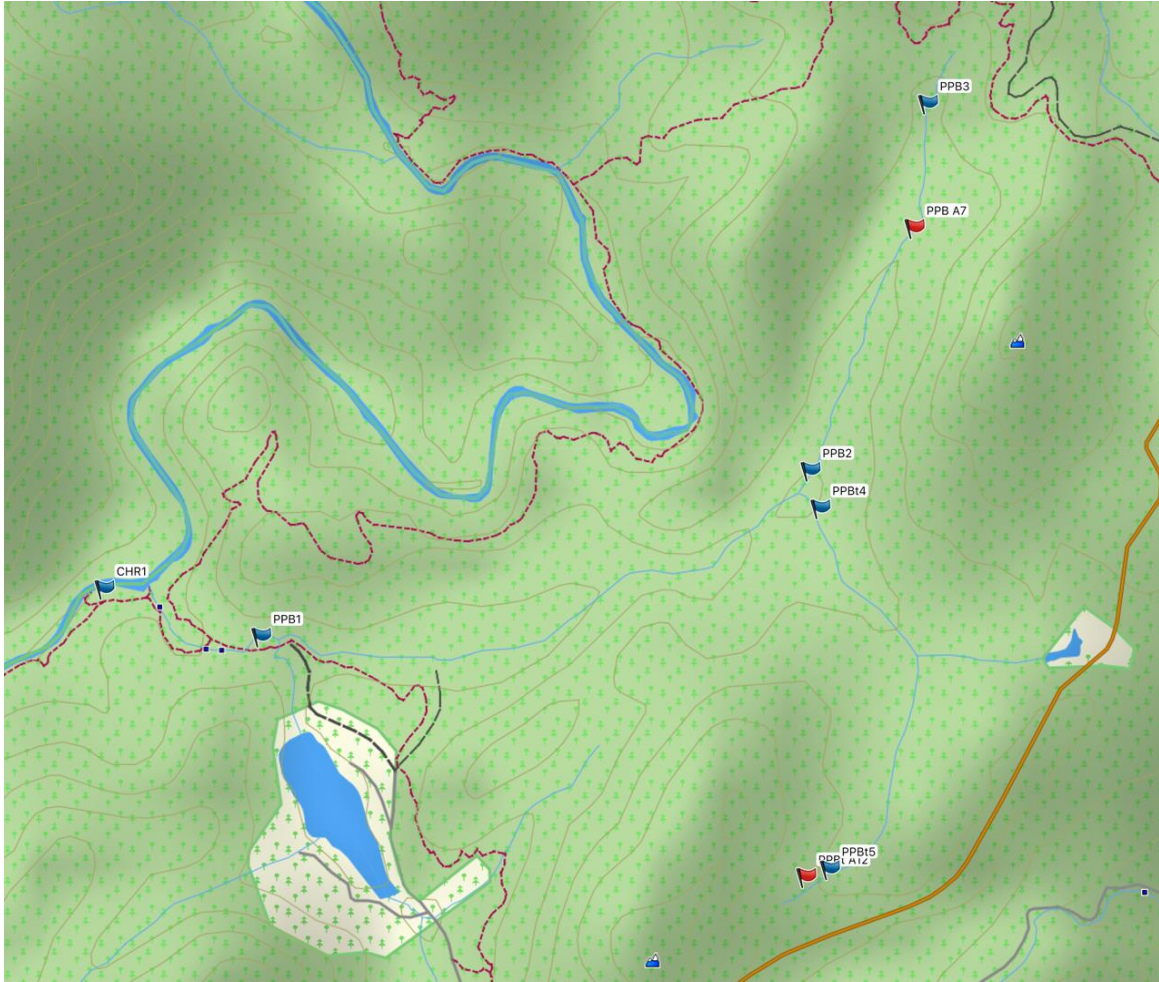
Figure 3. Aquatic invertebrate, crayfish and salamander monitoring stations located on Pig Pen Branch near Mountain Rest, South Carolina. Blue flags demark monitoring stations. Red flags demark the uppermost Antimycin treatment locations for the project.

Dr. Jeremy Pike, with Clemson University, conducted surveys of the aquatic invertebrates, crayfish, and salamander community in Pig Pen Branch and Lick Log Creek. Six sites were established with two control sites above the Antimycin treatment area where no fish are present, three sites within the Antimycin treatment area, and one below the detox site within the Chattooga River:

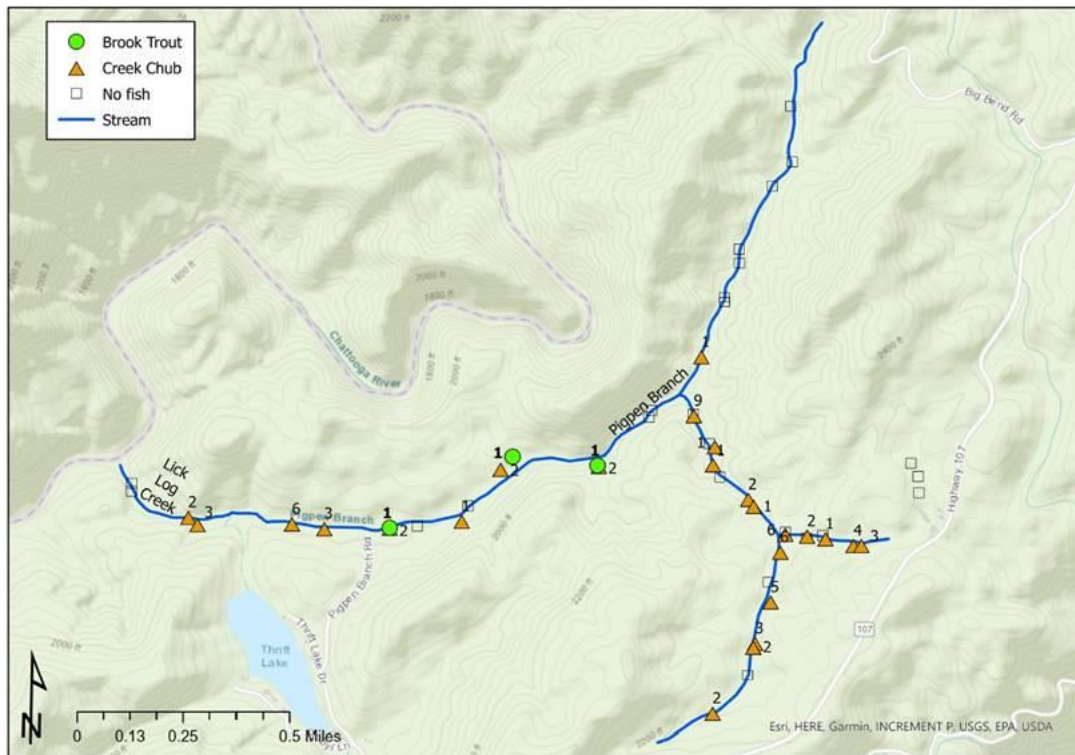
Figure 15. Eastern Brook Trout and Creek Chub distribution map based off fishing BVET surveys on Pig Pen Branch and Lick Log Creek.
